HALE PARISH COUNCIL

DATED THIS 5th JUNE 2024
MEMBERS OF HALE VILLAGE HALL MANAGEMENT COMMITTEE
ARE HEREBY SUMMONED TO ATTEND AN ORDINARY MEETING
TO BE HELD IN HALE VILLAGE HALL, HIGH STREET,
HALE, HALTON L24 4AE
ON 10th JUNE 2024 AT 8.00pm
TO TRANSACT BUSINESS AS SHOWN IN THE AGENDA.

Tree Condition Survey and Management Recommendations for Hale Village Community Hall

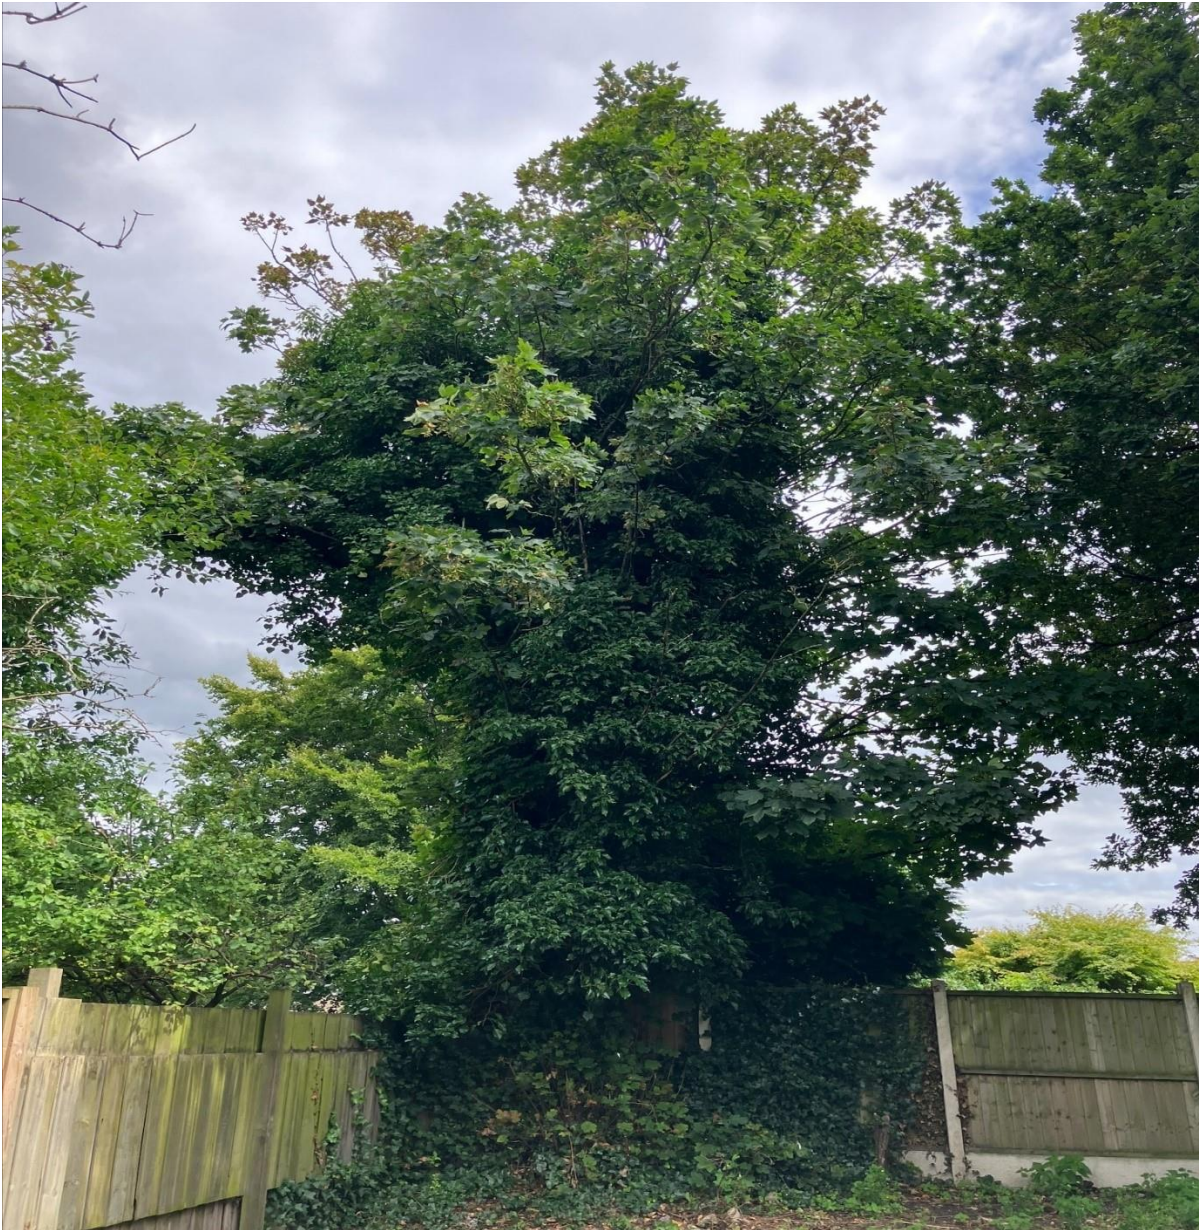
T1 Sycamore (*Acer pseudoplatanus*)

Figure 2 Photograph of T1 *Acer pseudoplatanus*

Description: Tree #1, *Acer pseudoplatanus*, the sycamore species, graces the northeast corner of the property. Its strategic location positions it at the confluence of three adjacent properties, where it plays a vital role in shaping the landscape. Unfortunately, the tree faces an encroaching challenge in the form of a dense ivy blanket, which cloaks its multi-stemmed structure up to an approximate height of 8 meters.

Regrettably, due to the pervasive ivy cover, we were unable to conduct a comprehensive inspection of the tree's condition.

The tree exhibits a characteristic feature of sycamores but has slender and elongated branches. This particular growth pattern renders the tree susceptible to the smothering effects of ivy. Following a comprehensive examination, no indications of bats roosting in the vicinity of the tree were observed. However, should any signs of bats' presence within the ivy emerge, it is imperative to engage a qualified expert for a thorough inspection before undertaking any tree-related activities. This approach aligns with the legal requirements set forth in the Wildlife and Countryside Act 1981 and the Conservation of Habitats and Species Regulations 2017.

Recommendations: In light of the prevailing circumstances, we strongly advocate for the removal of ivy from the tree at breast height. This course of action is of utmost importance as it will enable us to conduct a thorough Visual Tree Assessment (VTA) once the ivy foliage has naturally withered. Beyond facilitating a precise tree assessment, ivy removal serves a dual purpose. By reducing the competition for sunlight within the tree's canopy it will promote the growth of healthier foliage, thus enhancing the overall vitality and recovery potential of the sycamore.

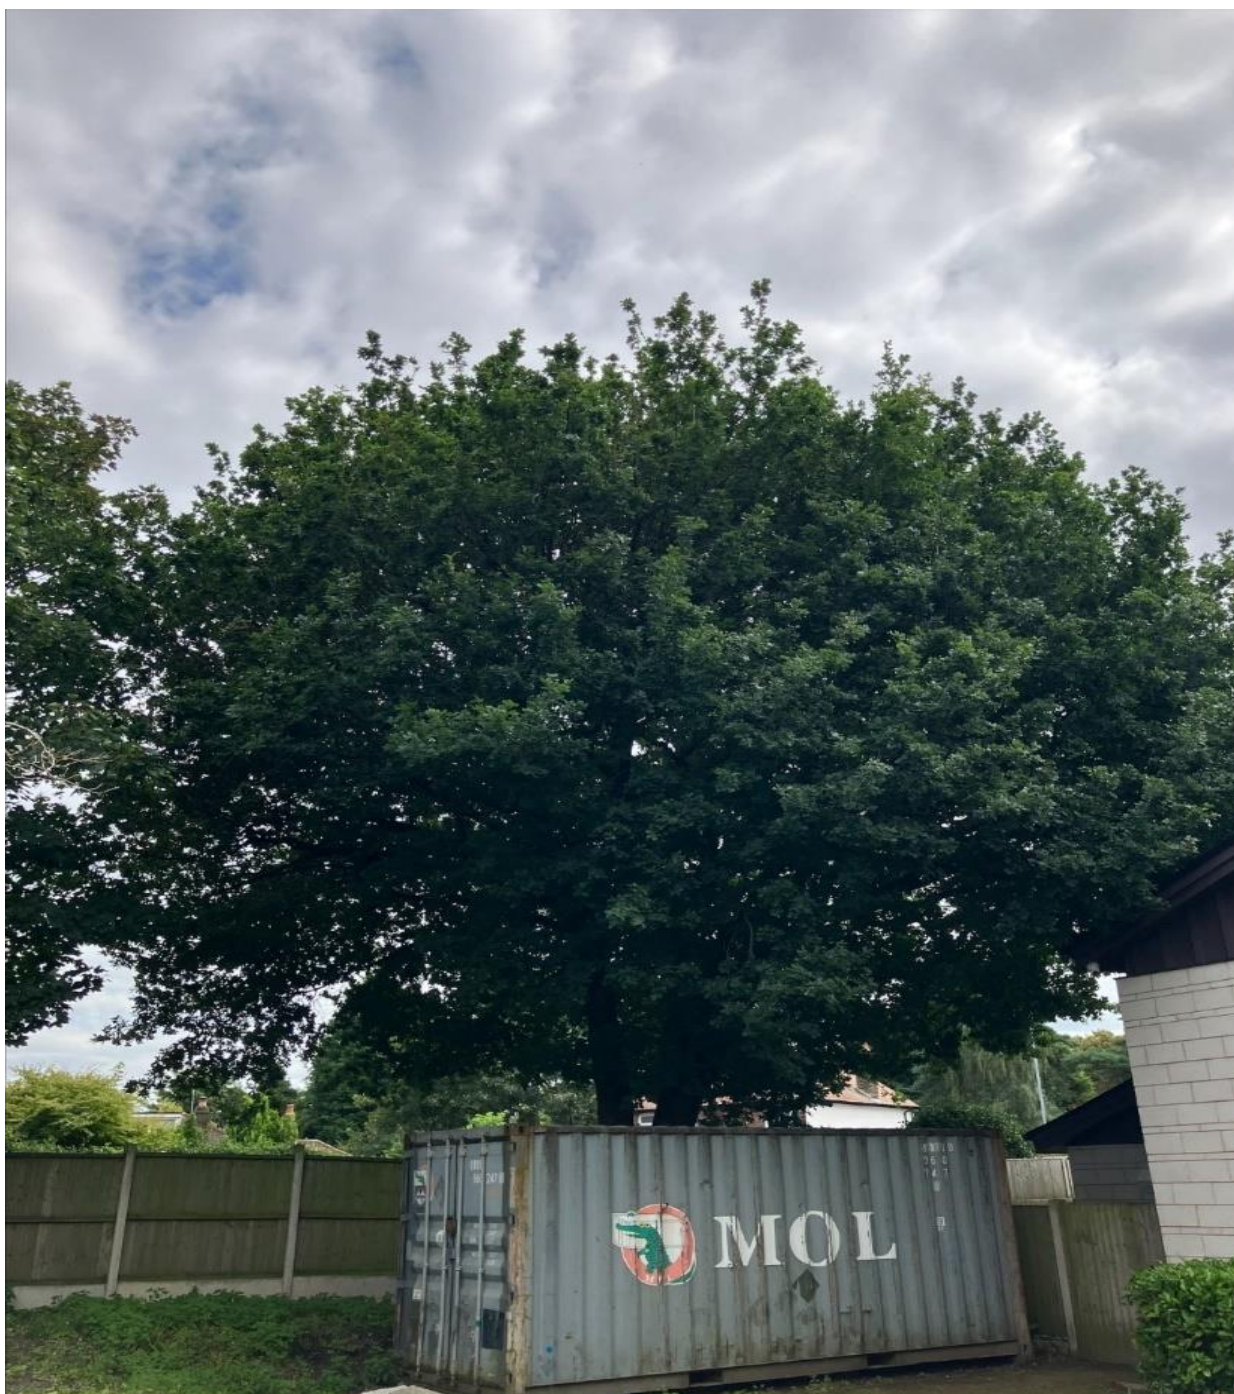
T2 Turkey Oak (*Quercus cerris*)

Figure 3 photograph of T2 *Quercus cerris*

Description: Nestled at the rear of the property, on its eastern boundary, stands Tree #2, a dignified specimen of *Quercus cerris*, recognised as the Turkey Oak. Its imposing stature graces the landscape as it shares borders with a neighbouring garden and stands in close proximity to the esteemed Village Hall.

Upon close examination, this tree reveals a history of meticulous pruning, evident through the presence of prior pruning wounds. While these wounds are healing, a slight hint of decay is discernible See appendix 000. However, a more pressing concern emerges at the foundation of the tree—the root plate. This critical structure harbours an accumulation of debris and rubble, remnants of past development activities on the

Recommendations: To preserve the well-being and endurance of this splendid Turkey Oak, we propose:

Clearing the Root Plate: Attention is required to clear the root plate from debris. This action will optimise the tree's access to vital nutrients and arrest any further degradation caused by the presence of debris.

Mulch Application: The application of a layer of mulch around the tree's base is pivotal in nurturing its overall health and vitality. Prudent mulching techniques must be employed to ensure the correct application of mulch that does not lead to excessive moisture retention around the tree's trunk, a condition that could potentially harm the tree.

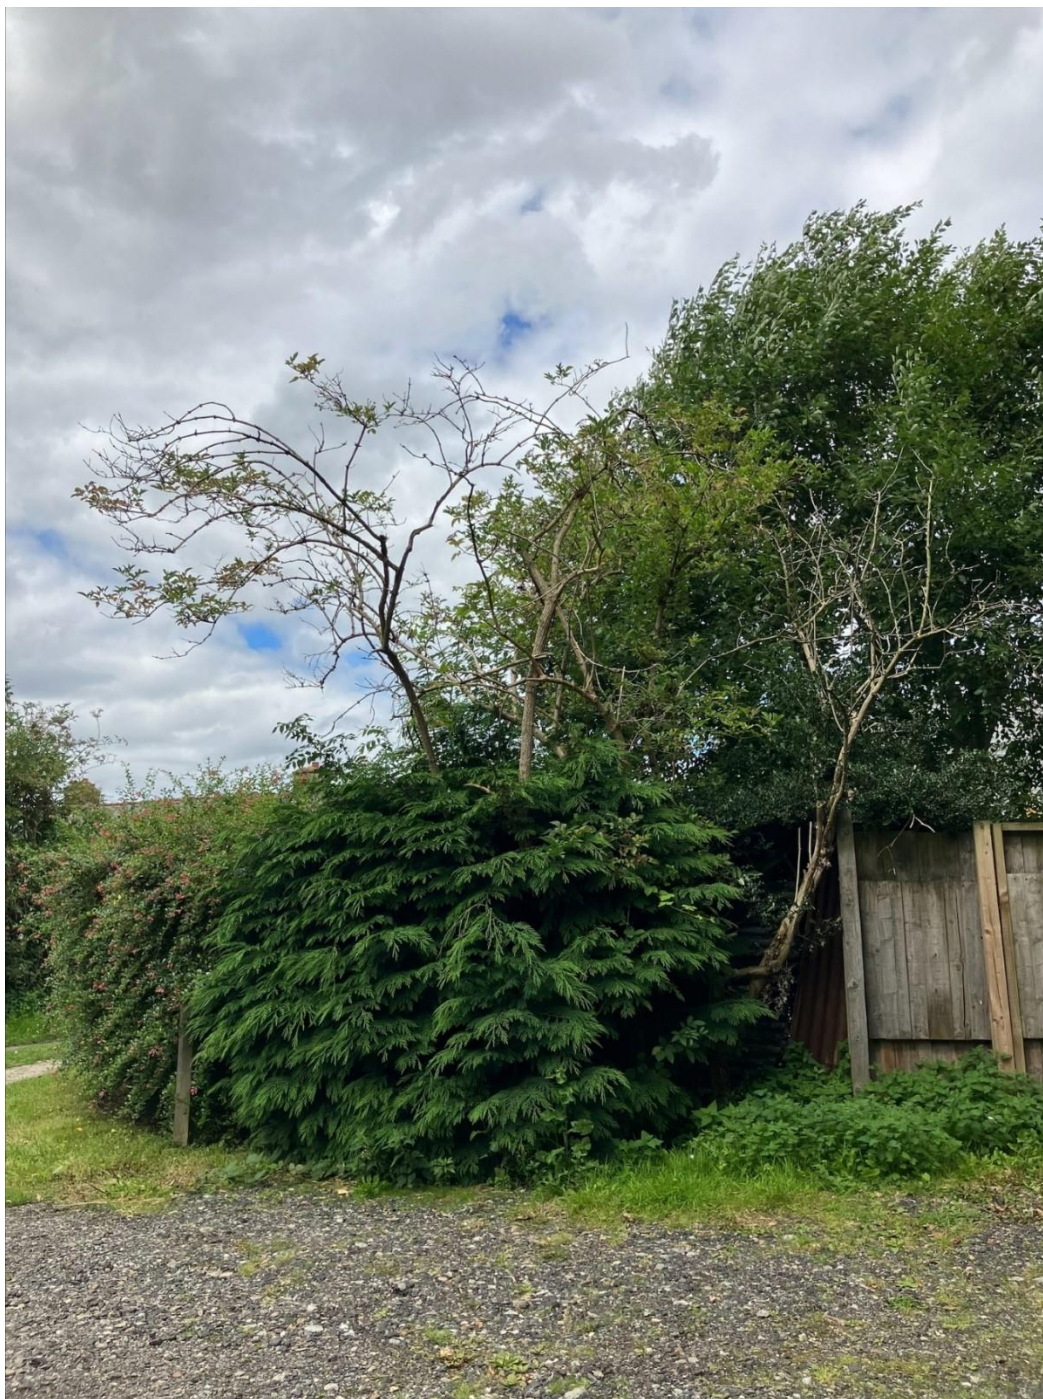
T3 Elder (*Sambucus nigra*)

Figure 4 Photograph of T3 *Sambuca nigra*

Description: Enveloped within the verdant tapestry of a leylandii hedgerow, Tree #3 emerges as a multi-stemmed young elder (*Sambucus nigra*). However, a thorough inspection of this arboreal presence was impeded by the luxuriant foliage that shrouds its form. This natural cloak of greenery concealed a disheartening revelation—Tree #3's current state of decline.

Recommendations: In light of these concerning observations, we strongly endorse a restorative course of action. Removal of the dead elder stem and deadwood, attention is warranted to address the deceased elder stem and eliminate any deadwood. This proactive step will not only enhance the tree's health but also rejuvenate its aesthetic appeal of the tree.

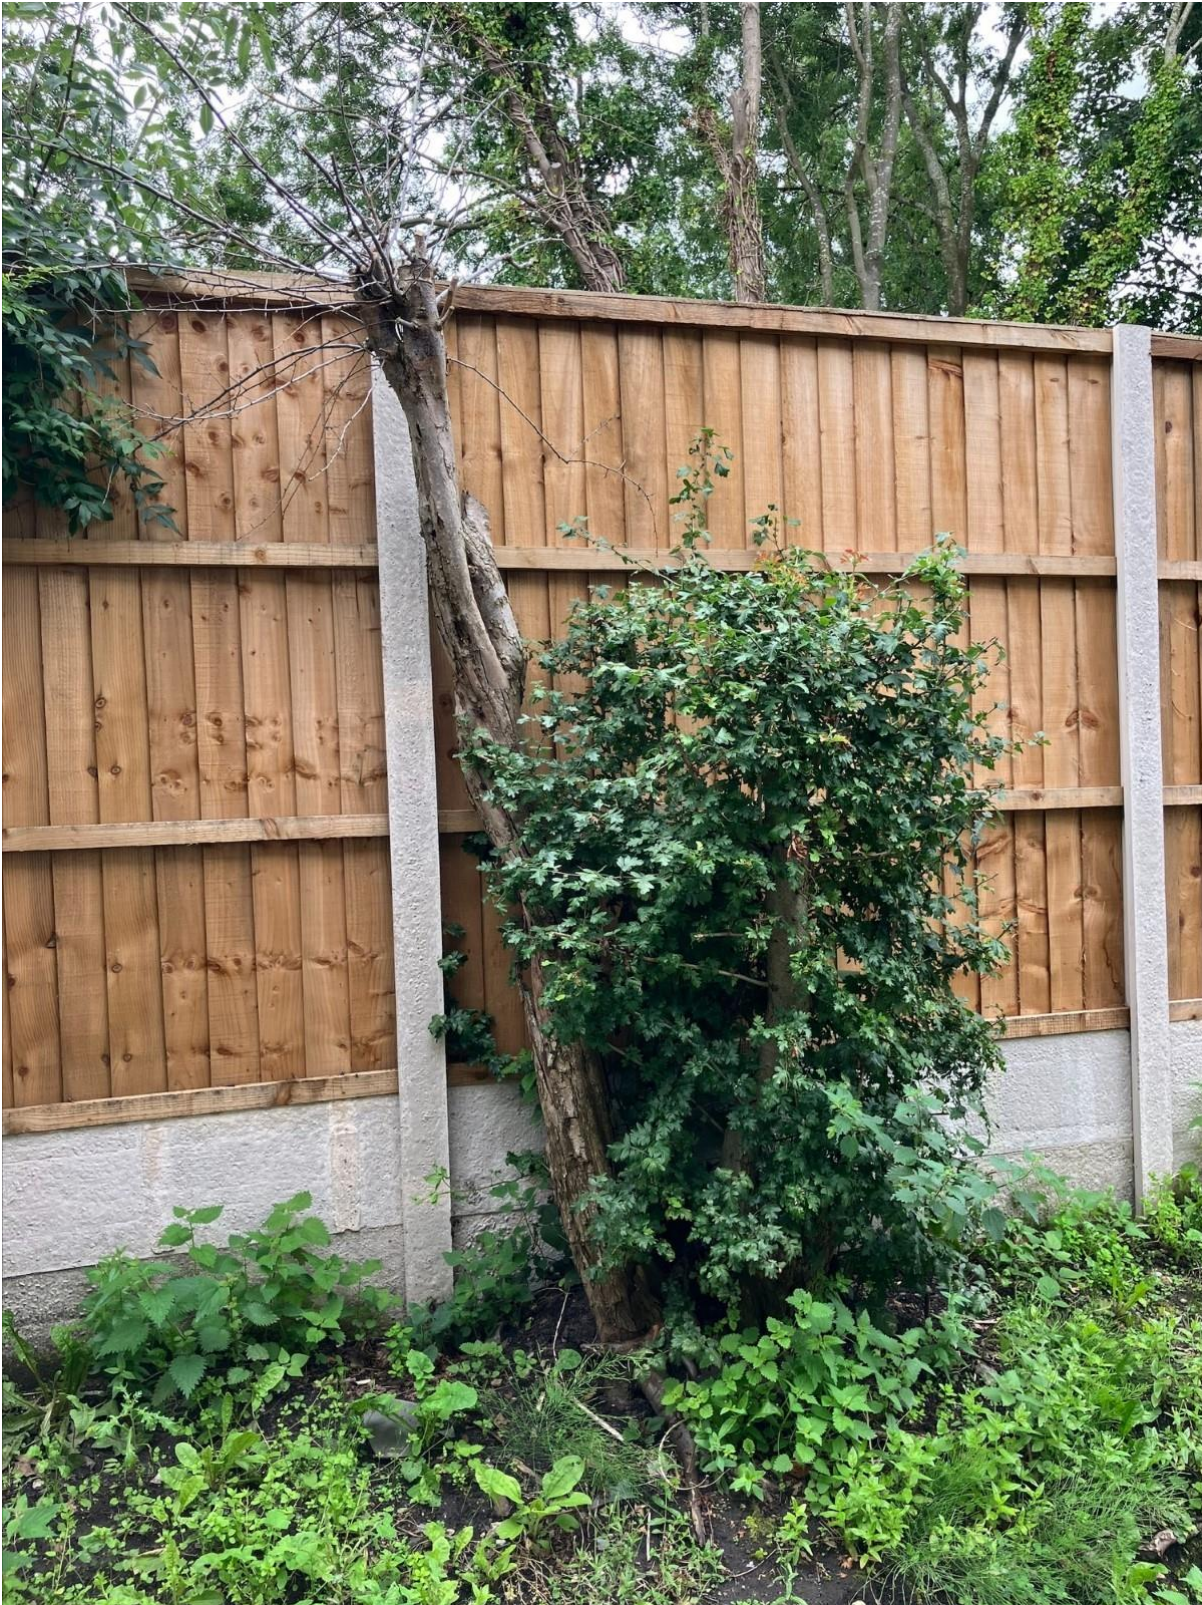
T4 Hawthorn (*Crataegus monogyna*)

Figure 5 Photograph of t4 *Crataegus monogyna*

Description: Situated alongside the property's footpath, Tree #4 stands as a small Hawthorn (*Crataegus monogyna*) species. Its nature as a hedge and the luxuriant foliage that blankets its stem rendered a comprehensive inspection a challenging endeavour. Nonetheless, our observations have unveiled a few key characteristics of this small, yet resilient, bush. This inspection was an exception to limitations 3.2 and has been added to this report as an example for advice on hedgerow management.

Recommendations: In response to the findings, we propose a proactive strategy to uphold the tree's vitality and ornamental value:

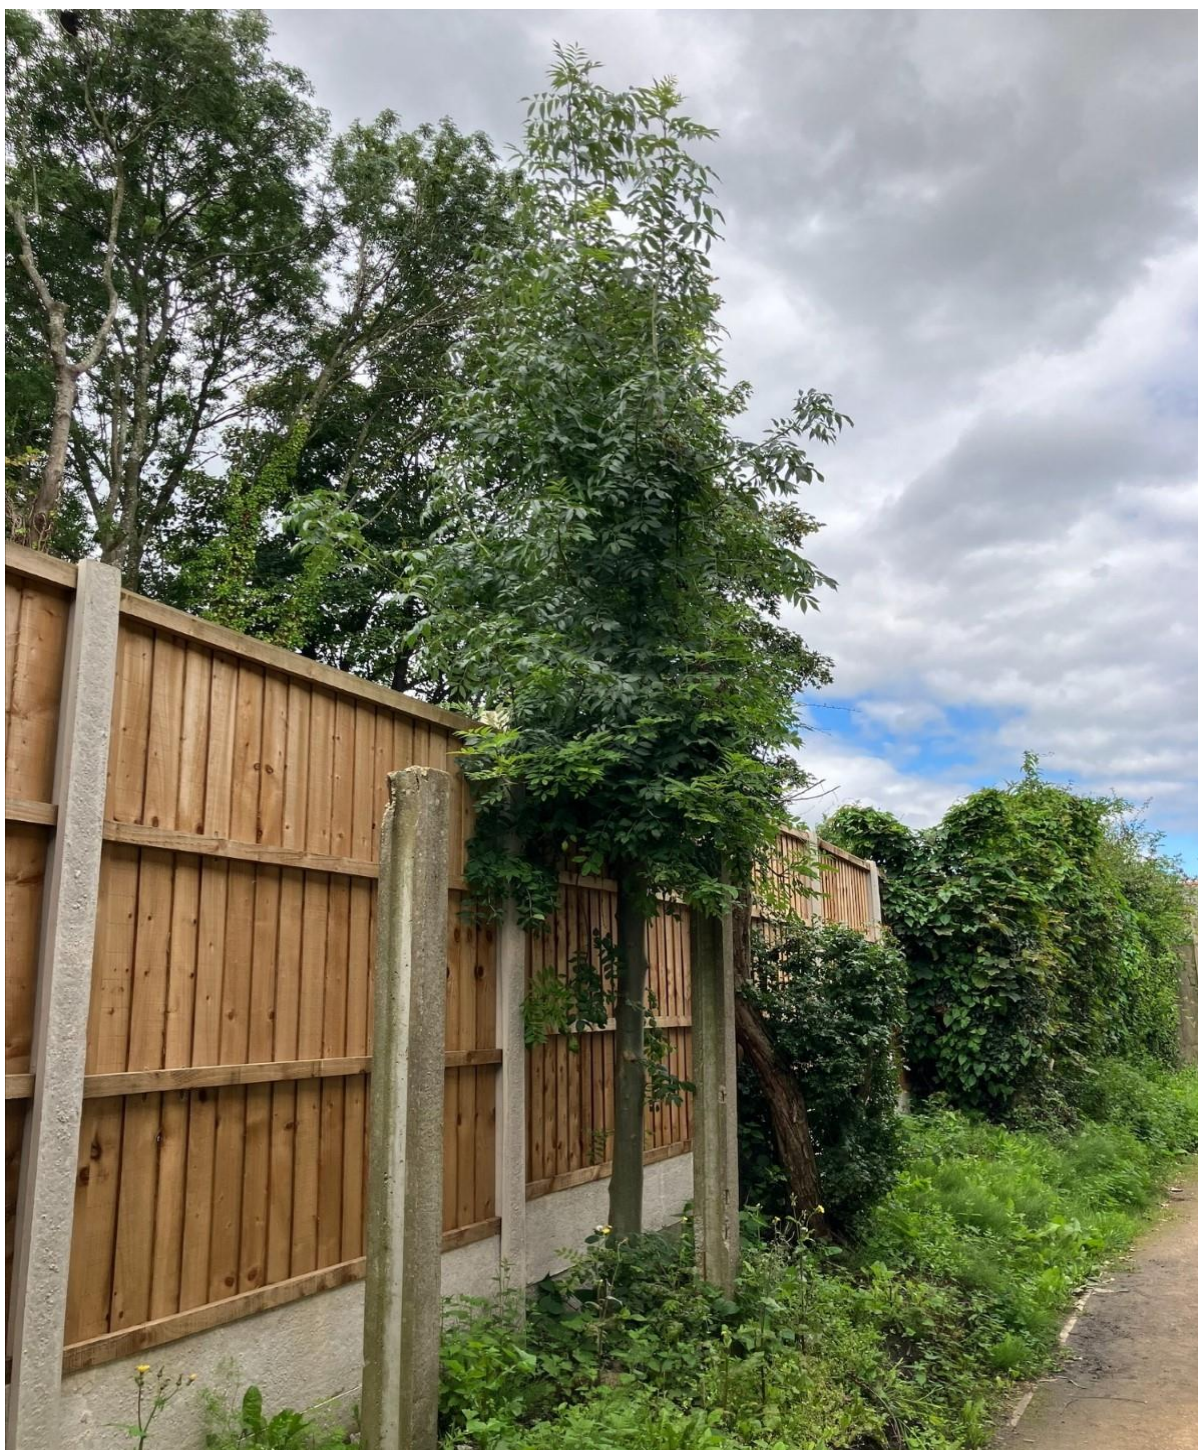
T5 Ash (*Fraxinus excelsior*)

Figure 6 photograph of t5 *Fraxinus excelsior*

Description: Settled on the eastern side of the footpath, Tree #5 is a young Ash (*Fraxinus excelsior*). This young specimen stands as a testament to nature's resilience and vitality. A careful examination of the tree reveals a thriving presence, characterised by its robust and full canopy of foliage.

Recommendations: In the absence of any visible signs of ash dieback, to maintain its health and to monitor for potential issues, we propose the following recommendations:

Monitoring for Ash Dieback: Given the absence of ash dieback at present, we recommend monitoring this tree for the disease every two years. However, it is essential to underscore the flexibility in inspection frequency. The frequency of monitoring should adapt to the tree's development and any evolving threat of ash dieback in the area.

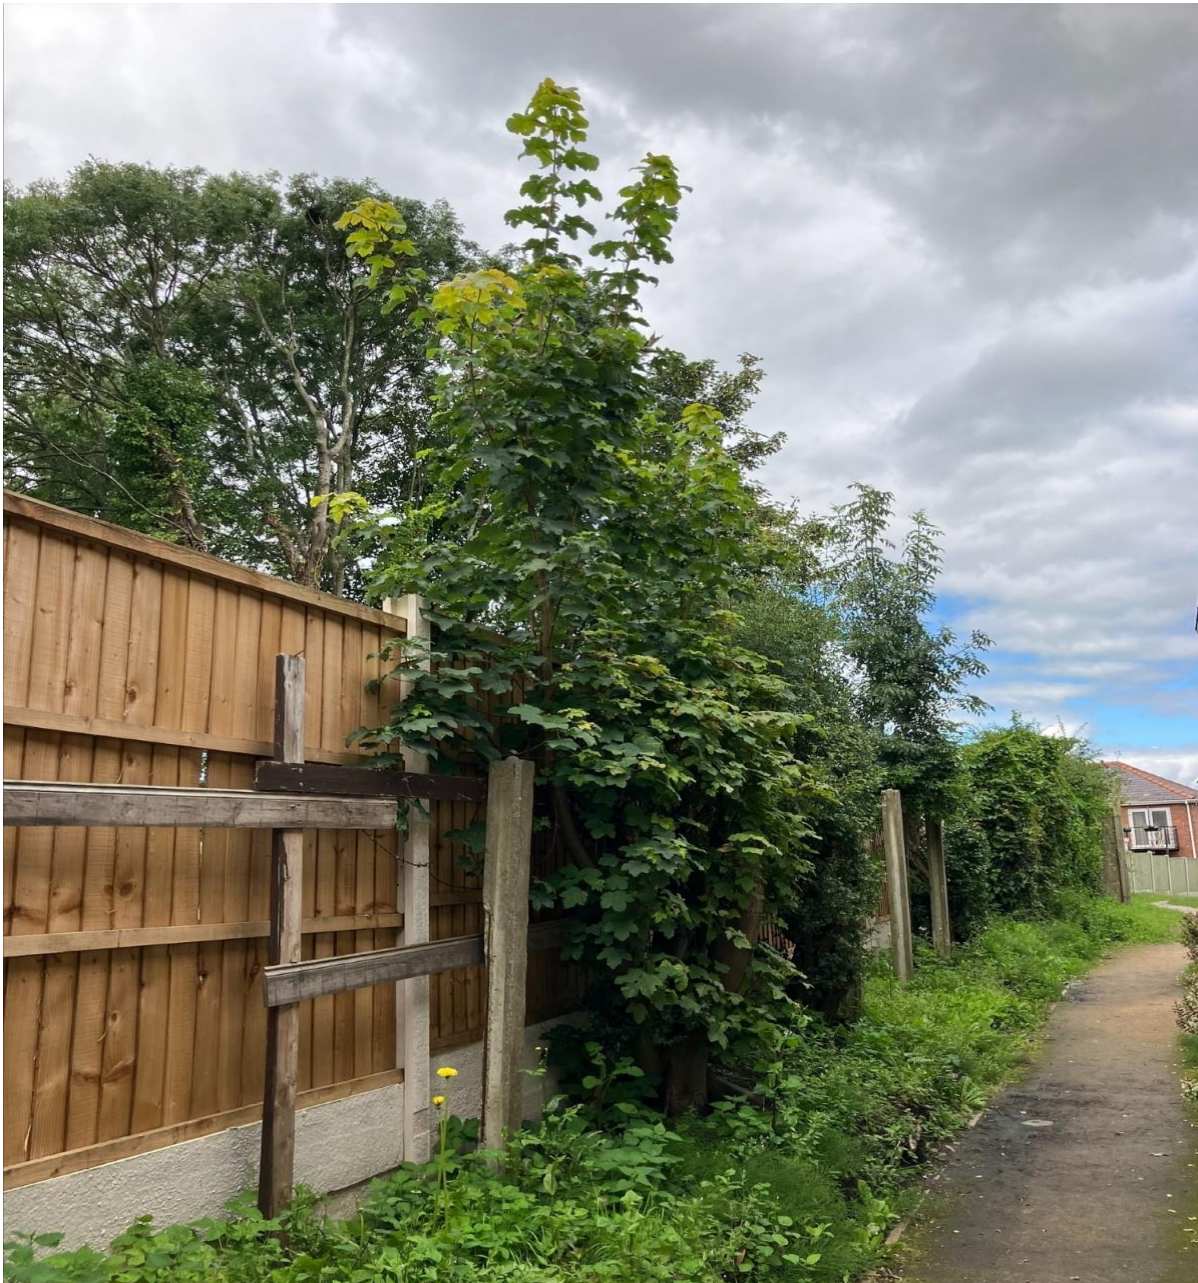
T6 Sycamore (*Acer pseudoplatanus*)

Figure 7 photograph of t6 *acer pseudoplatanus*

Description: Placed east of the footpath near the property's boundary line, Tree #6 stands as a multi-stemmed Sycamore (*Acer pseudoplatanus*). Its history of losing its main stem has sculpted its appearance, resulting in a compact multi-stemmed form. However, a closer examination reveals signs of decay within the old main stem.

Recommendations: In the context of trees located within a conservation area in the UK, it's important to acknowledge that tree work on specimens with a trunk diameter measuring less than 7.5 centimetres does not necessitate prior notice to the local planning authority. This exemption is rooted in recognition that smaller invasive trees within conservation areas can be managed without the formalities of notification, provided that such work adheres to pertinent conservation laws and regulations. Nonetheless, it remains crucial to exercise due diligence, as the specific regulations governing tree preservation may exhibit variations by location regarding the Town and Country Planning (Tree Preservation) (England) Regulations 2012. Keep in mind that in conservation areas, you generally need to give your local planning authority six weeks' notice (known as a "Section 211 Notice") before carrying out tree work on certain trees. During this time, the local authority will consider whether to issue a Tree Preservation Order (TPO) to protect the trees.

Tree Removal: Given the tree's diminutive size and potential growth size, it would be advisable to remove this tree before it garners the protection of the conservation order. This tree has the future potential to outgrow its location and become a hazard in the next few years. Carrying out this action at this time would be in adherence to conservation area regulations. The removal of Tree #6 aligns with the established guidelines. This course of action maintains compliance with the law.

Consider Replacement: As a responsible measure to enhance the local environment, we recommend contemplating the introduction of a Dog Rose (*Rosa canina*) or an appropriate native species that would work as part of a hedgerow. This thoughtful replacement strategy contributes positively to the ecological balance of the area.

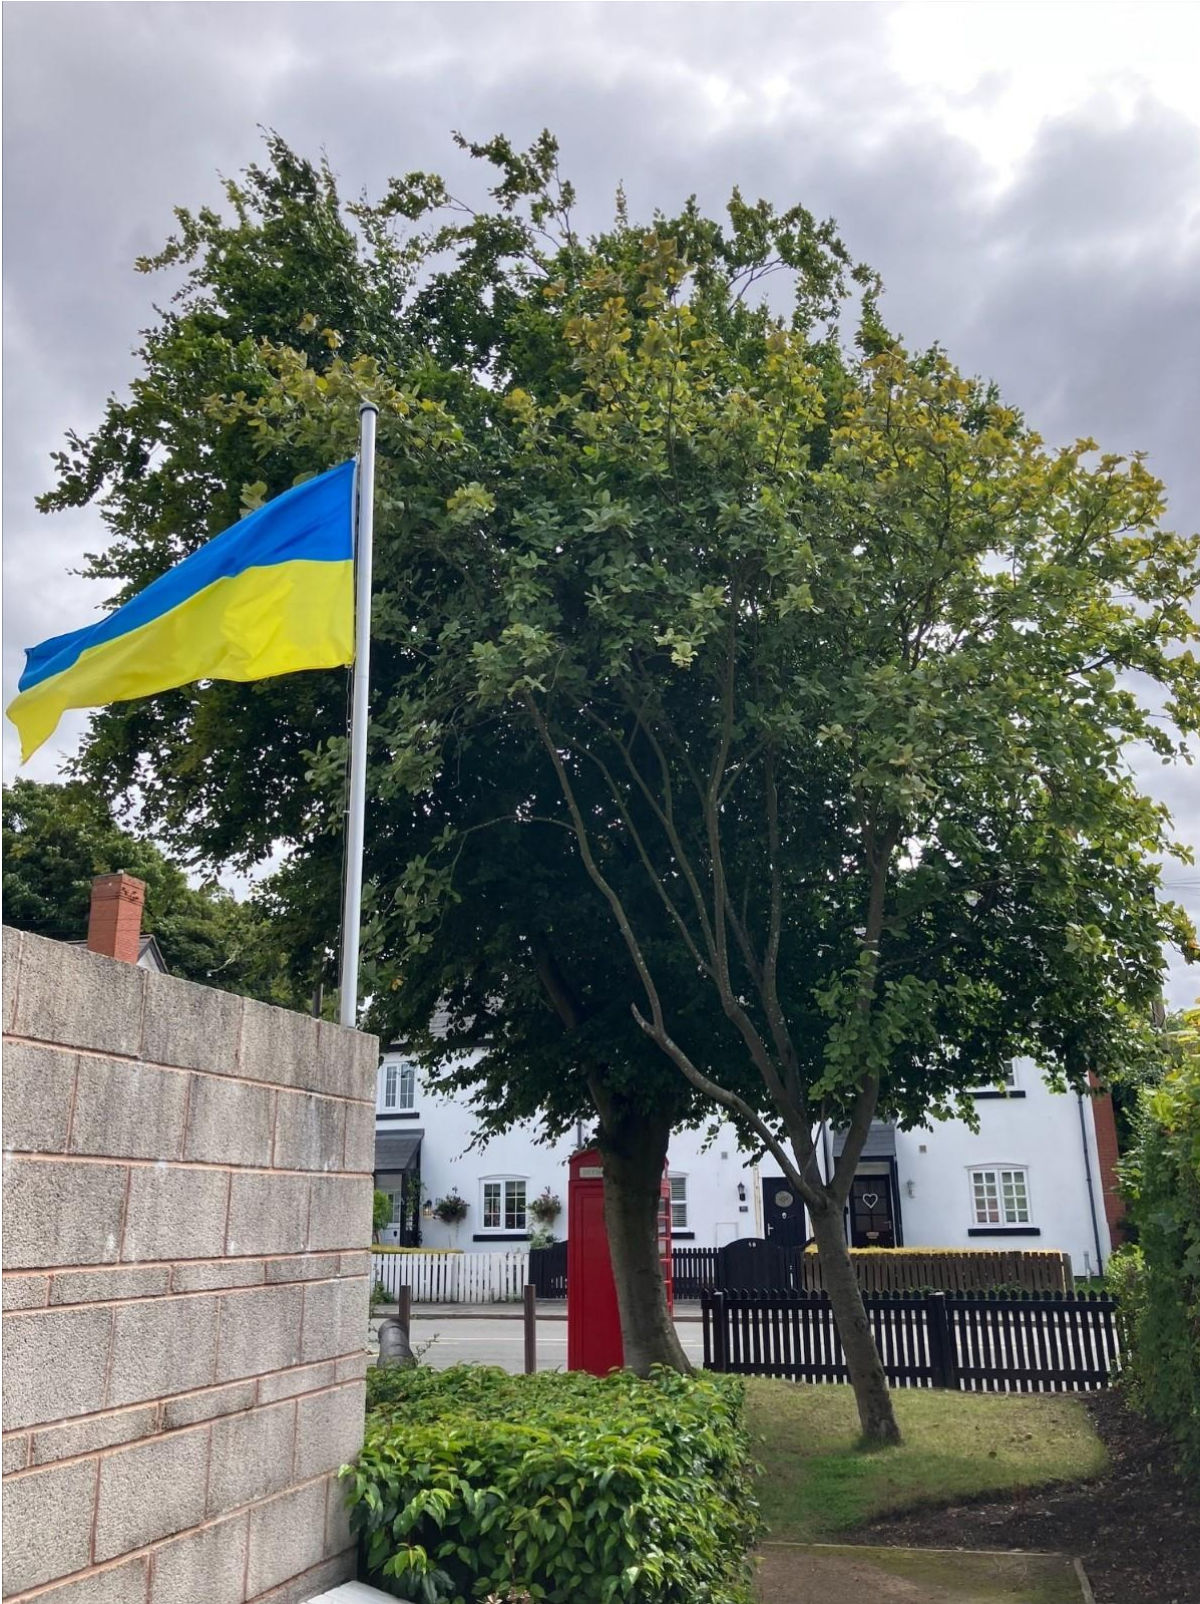
T7 Whitebeam (*Sorbus aria*)

Figure 8 photograph of t7 *sorbus aria*

Description: On the grass near the property's south entrance, Tree #7 stands a Whitebeam (*Sorbus aria*). It shares a closely adjoining canopy with a neighbouring beech tree. However, an in-depth examination has unveiled certain noteworthy characteristics that warrant consideration.

While the tree retains a substantial portion of its canopy, approximately 60% remains, it has experienced minor limb loss. The consequence of this loss is an altered canopy spread, with notable variation in different directions. Of particular concern is the presence of mechanical damage at the base of the tree's stem. This damage poses potential risks to the tree's structural integrity and longevity.

Recommendations: To ensure the well-being and continued vitality of Tree #7, we propose a multifaceted strategy:

Mulch Application: We strongly recommend the application of mulch around the base of the tree. Mulching represents a practical and beneficial practice that not only safeguards the tree from potential mechanical damage but also contributes significantly to its health, growth, and visual appeal. It is imperative to adhere to proper mulching techniques, ensuring that the mulch is applied correctly to prevent issues such as excessive moisture retention against the tree's trunk.

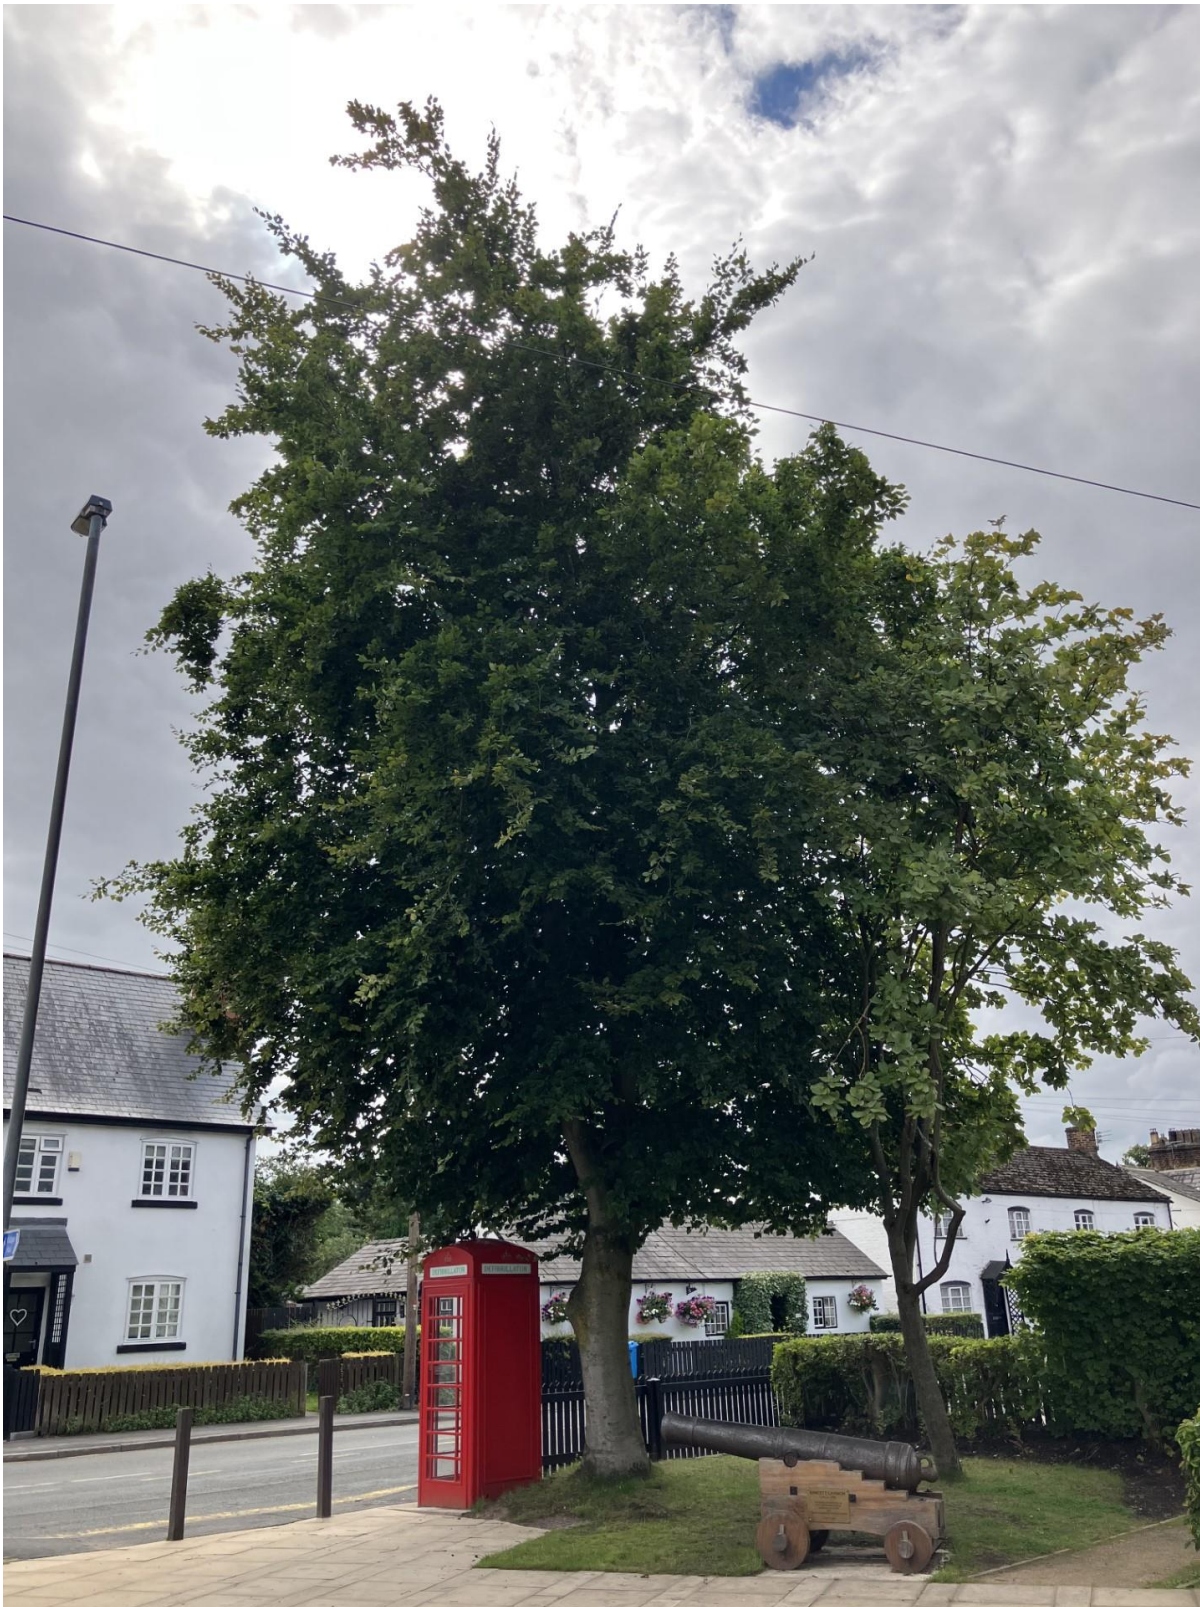
T8 Beech (*Fagus sylvatica*)

Figure 9 Photograph of t8 *Fagus sylvatica*

Description: Tree #8, a stately Beech (*Fagus sylvatica*), graces the landscape near the property's southern entrance, a location adorned with a nearby phone box. This specimen boasts a double stem configuration at approximately 2 meters up the stem. An intriguing discovery in the vicinity of the tree includes the

Recommendations: In light of the tree's current condition and the potential ecological significance of bird nesting activities, we propose the following course of action:

Tree Inspection: To ensure the continued health and structural integrity of Tree #8, we recommend conducting a thorough tree inspection every 24 months. Regular inspections allow for the early detection of any emerging issues and provide an opportunity for timely intervention if necessary.

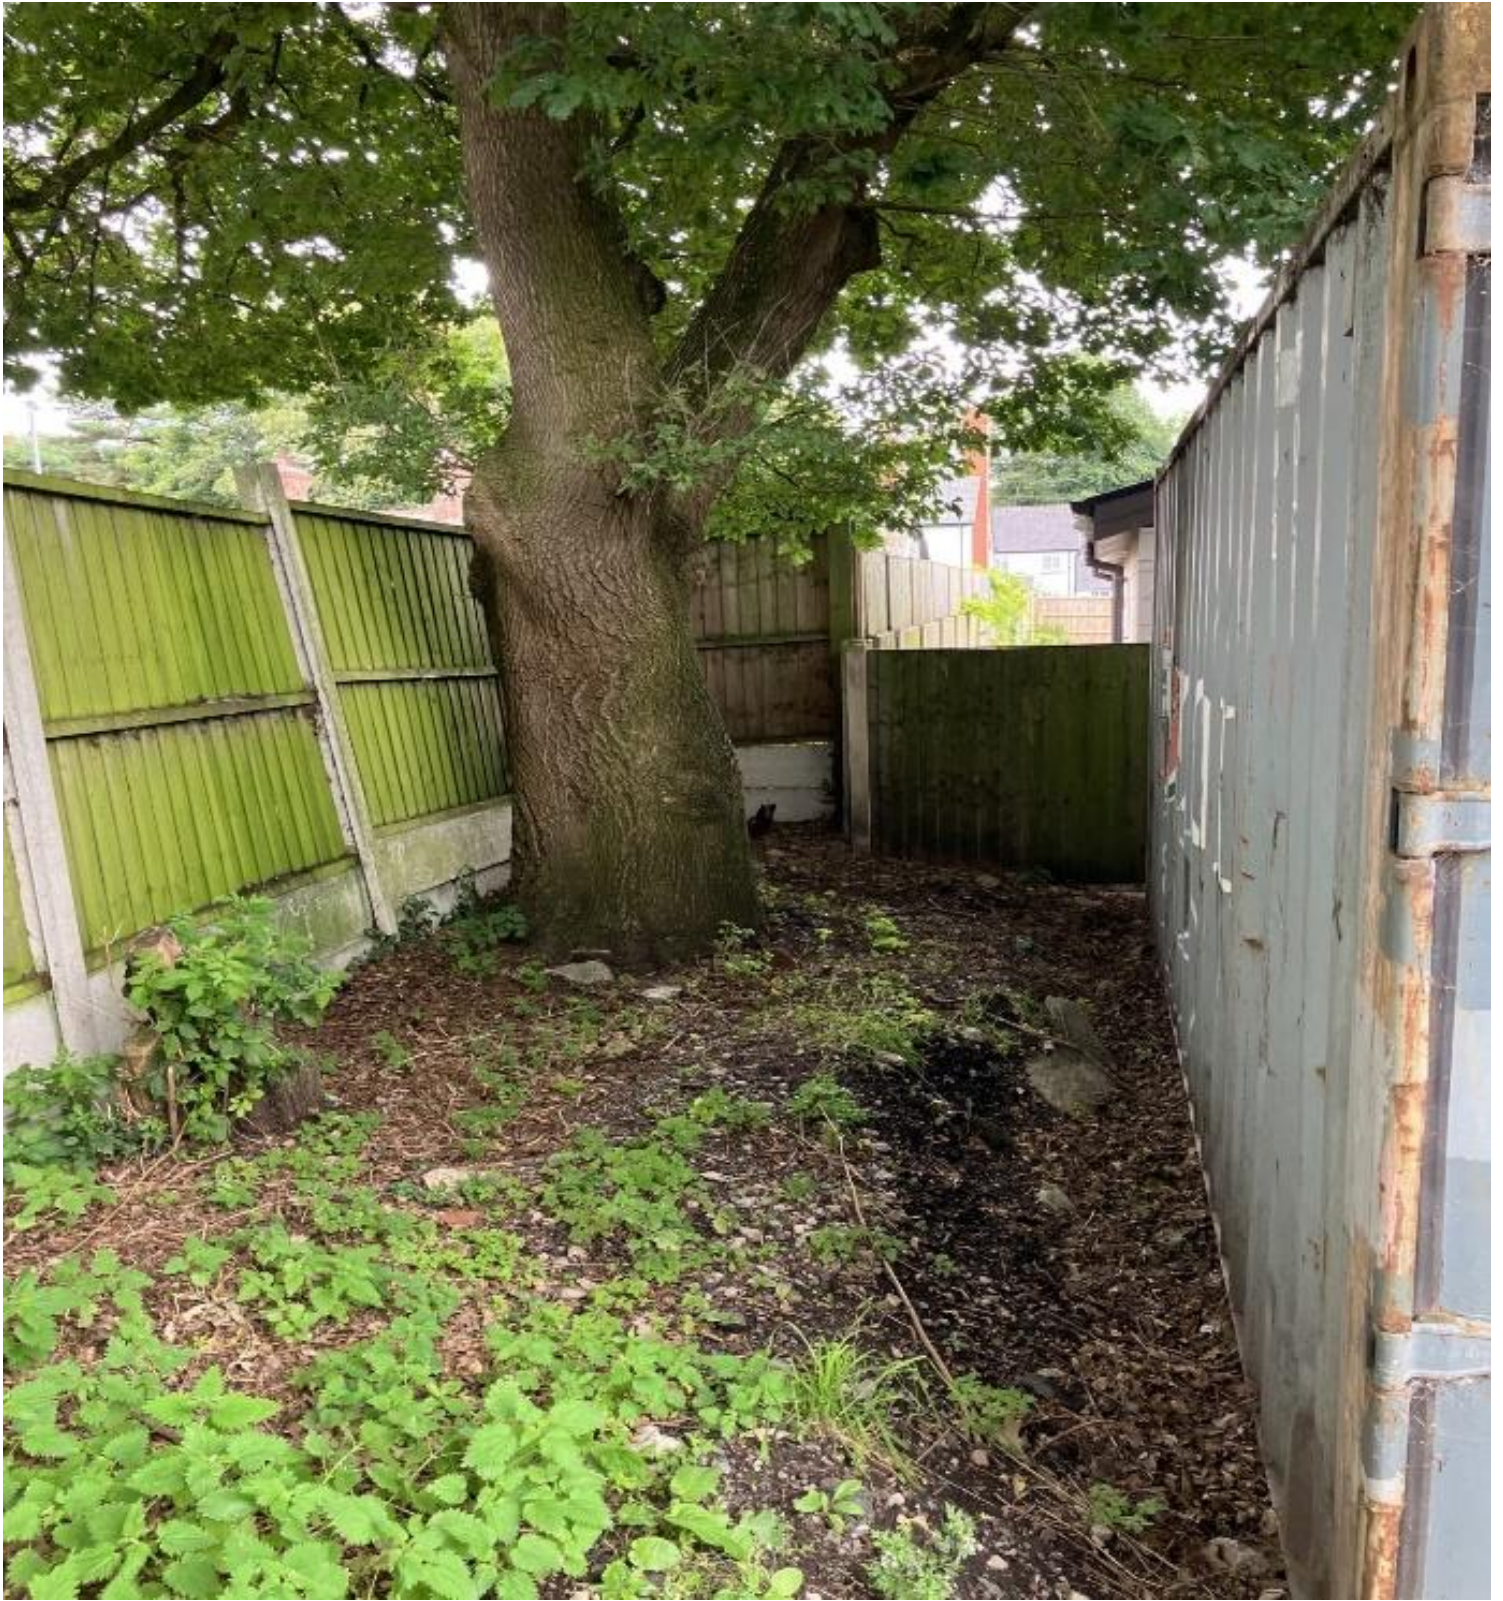
Figure 11 Suspected root excavation on T2

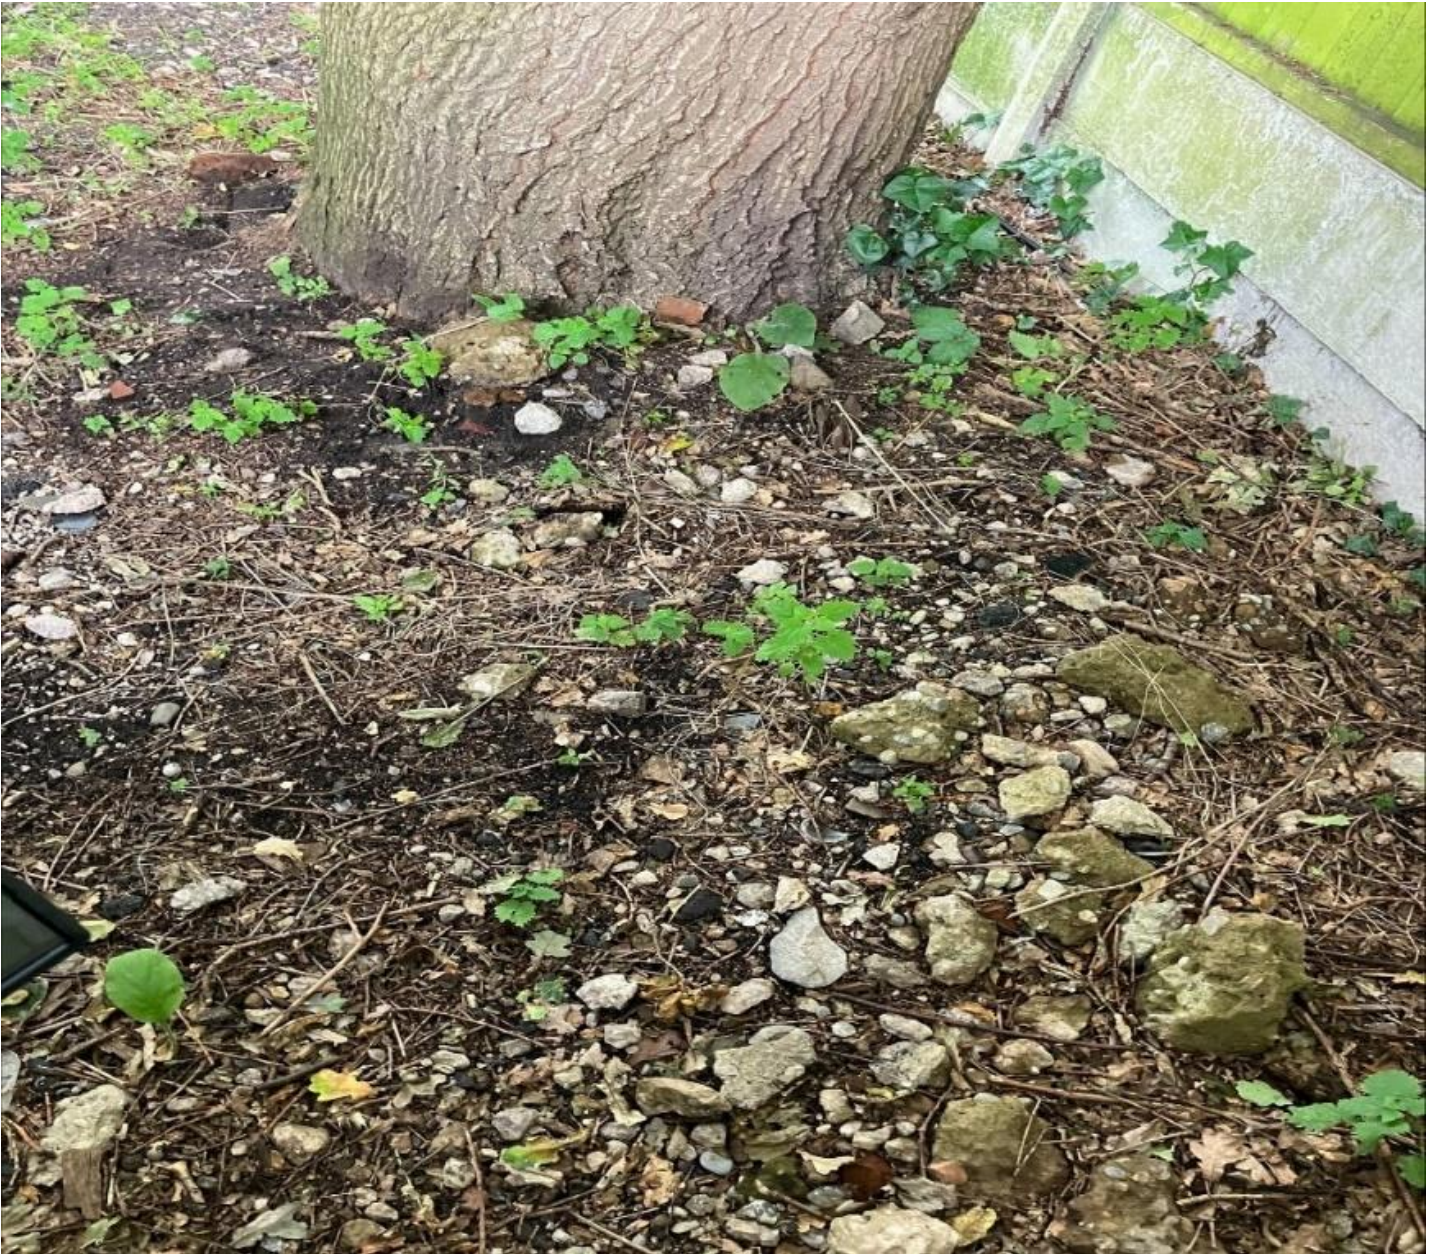
Figure 12 Rubble and debris in root area.

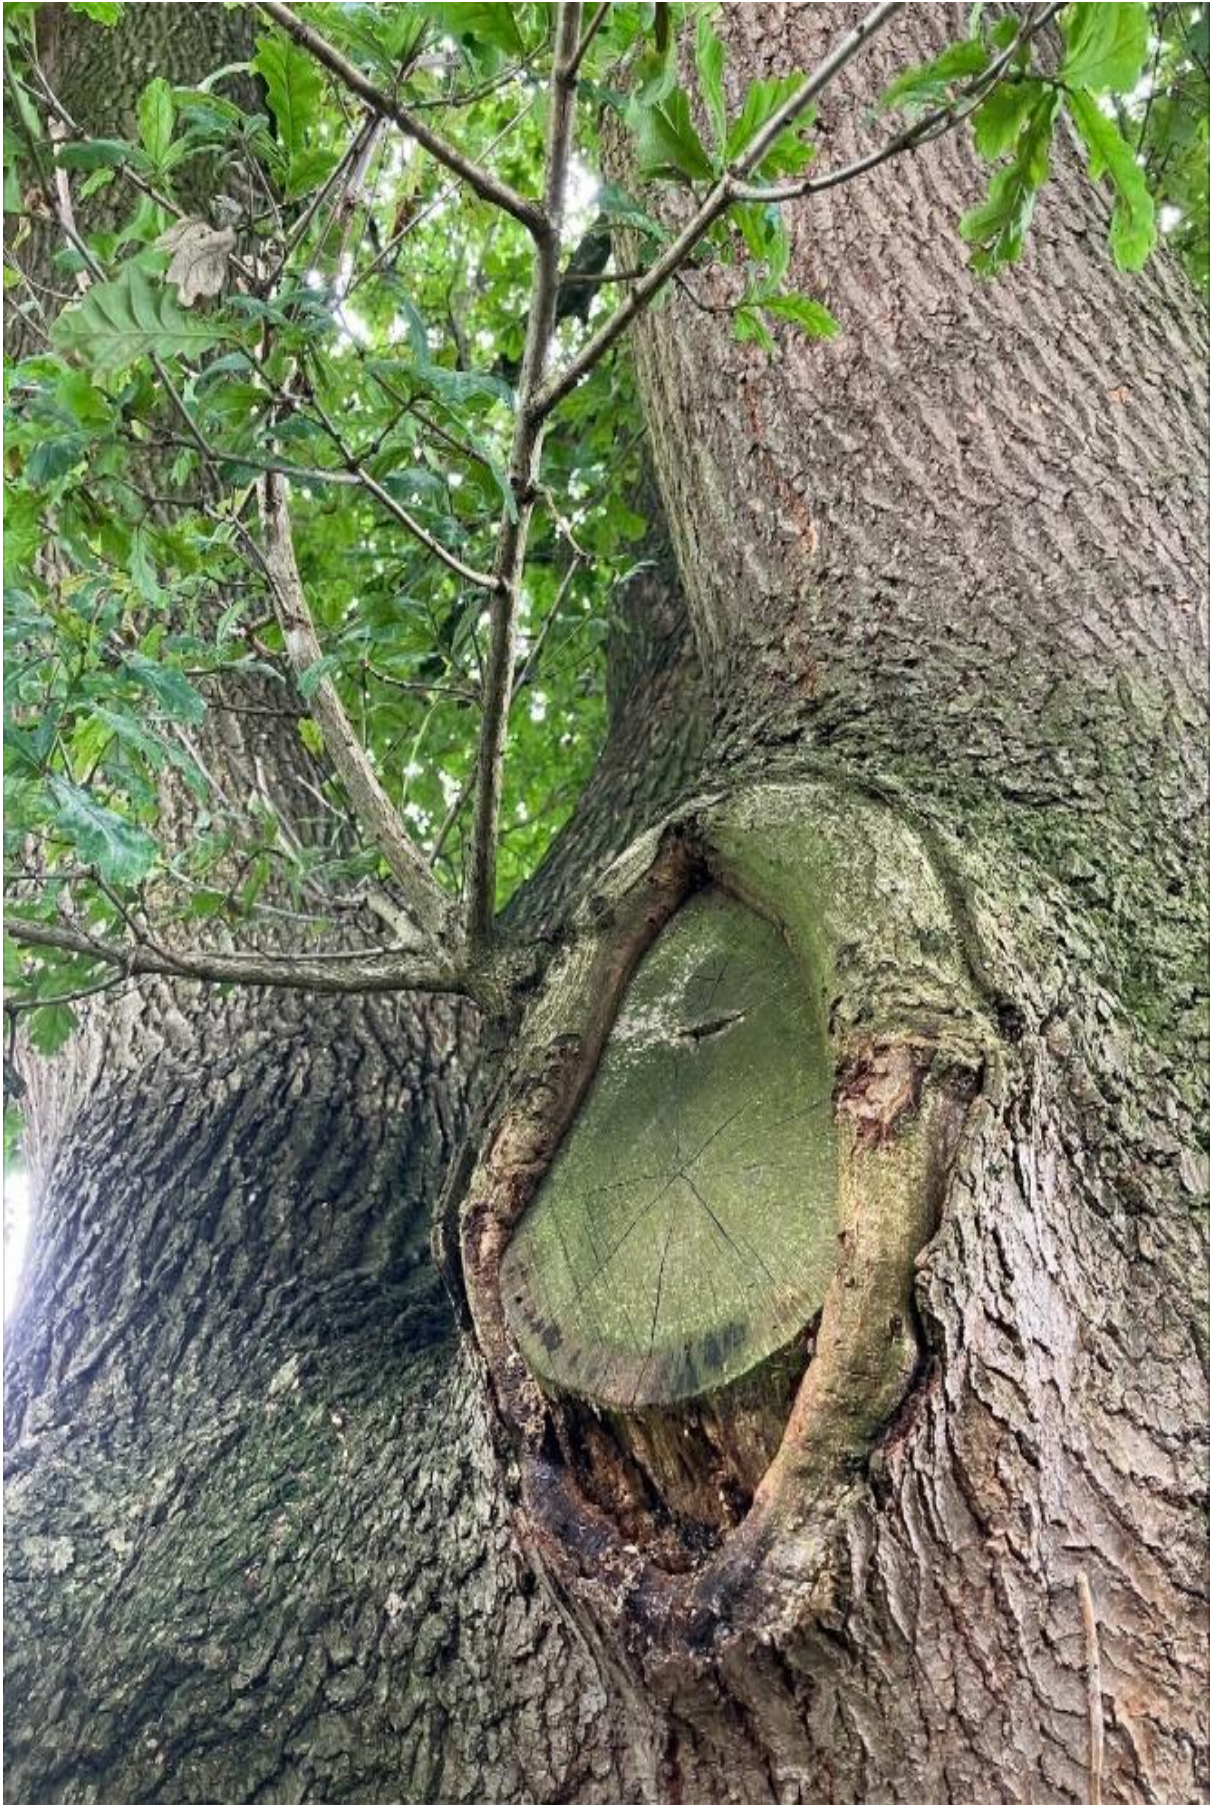
Figure 13 Previous pruning wound with occluding bark
